COUNTRY USSR (Ukrainian SSR) REPORT [REDACTED]  
 SUBJECT Naval Vessels in the Odessa Area DATE DISTR. 14 January 1959

Two reports describing Soviet naval vessels observed in and around Odessa harbor [REDACTED]

WARSHIPS AT ODESSA.

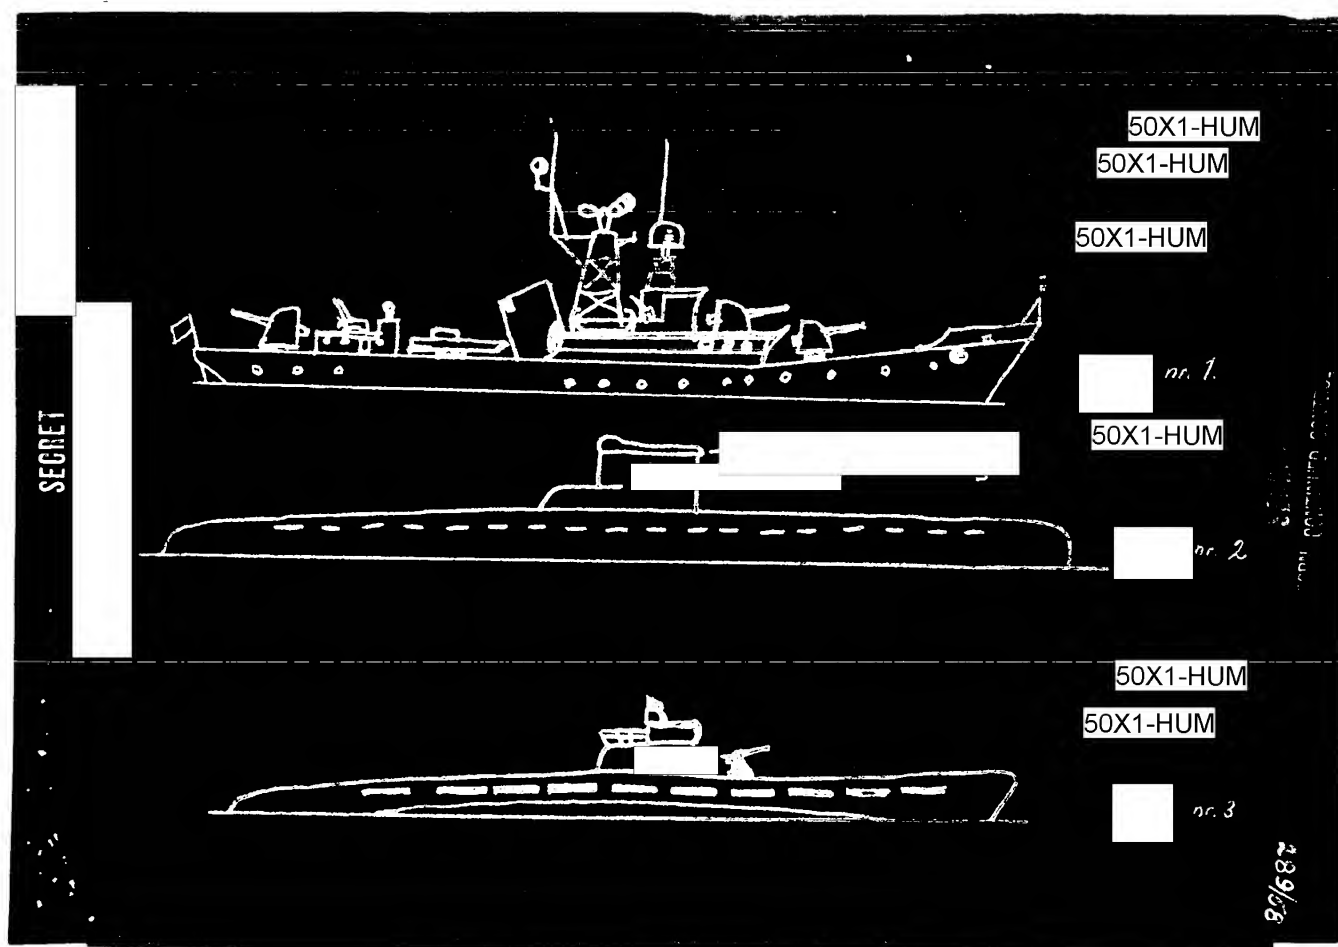
**Comment:** From the sketch, the unidentified "destroyers" appear to be RIGA-class escort vessels. Available information, confirmed by the sketches, indicates that

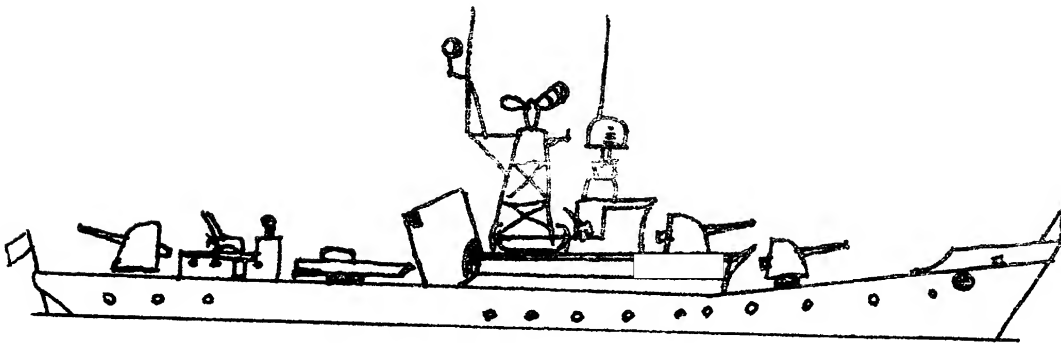
50X1-HUM  
nr. 1.

[REDACTED] Flat deckers with marked spring and high bow, two cannons, each in its shield on the forecastle, bridge with spherical central viewer on the top, mast, smokestack, torpedo-cannon, decks-house and cannon in shield.

See sketch No. 1.

[REDACTED] length about 275 feet. The vessel seemed to be 50X1-HUM lying in dry-dock. See sketch No. 2

Three subs were alike [REDACTED] Length estimated at about 200 feet. See sketch No. 3.

Flat deckers with raked spring and high bow, two cannons, each in its shield on the fore-castle, bridge with spheric tower on the top, mast, smokestack, torpedo-cannon, decks-house and cannon in shield. See sketch No. 1.

Length about 275 feet. The vessel seemed to be lying in dry-dock. See sketch No. 2

Three subs were alike. Length estimated at about 200 feet. See sketch No. 3.
